ANNUAL INSPECTION REPORT
Cessna 172L Skyhawk N7100Q
Serial No. 17260400

March 17, 2005

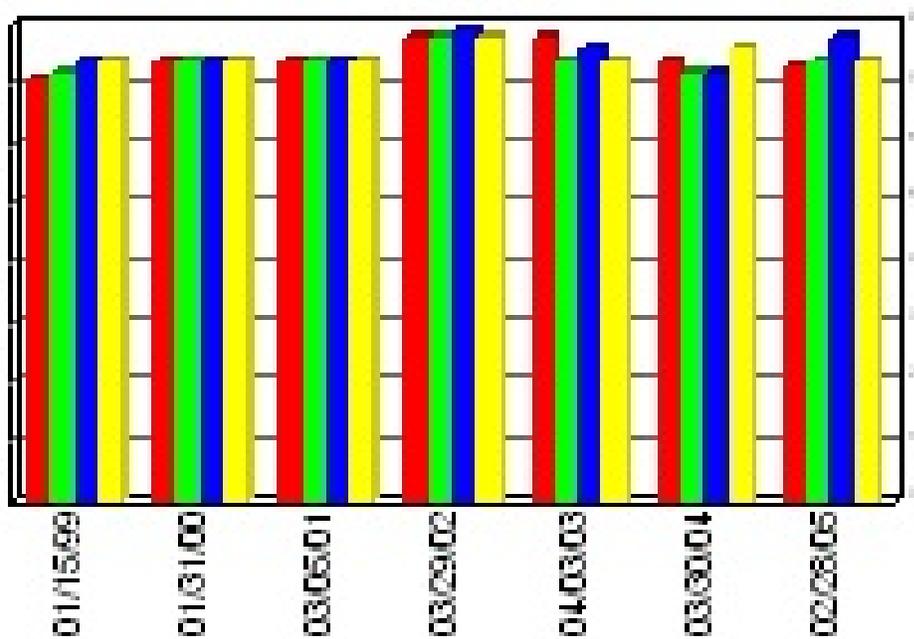
Cylinder Compression Results

We should continue to monitor oil use. When the engine is cold after starting allow it to warmup at low RPM. The cylinder compression test also indicates a strong engine. The Figures below graph these engine health parameters.

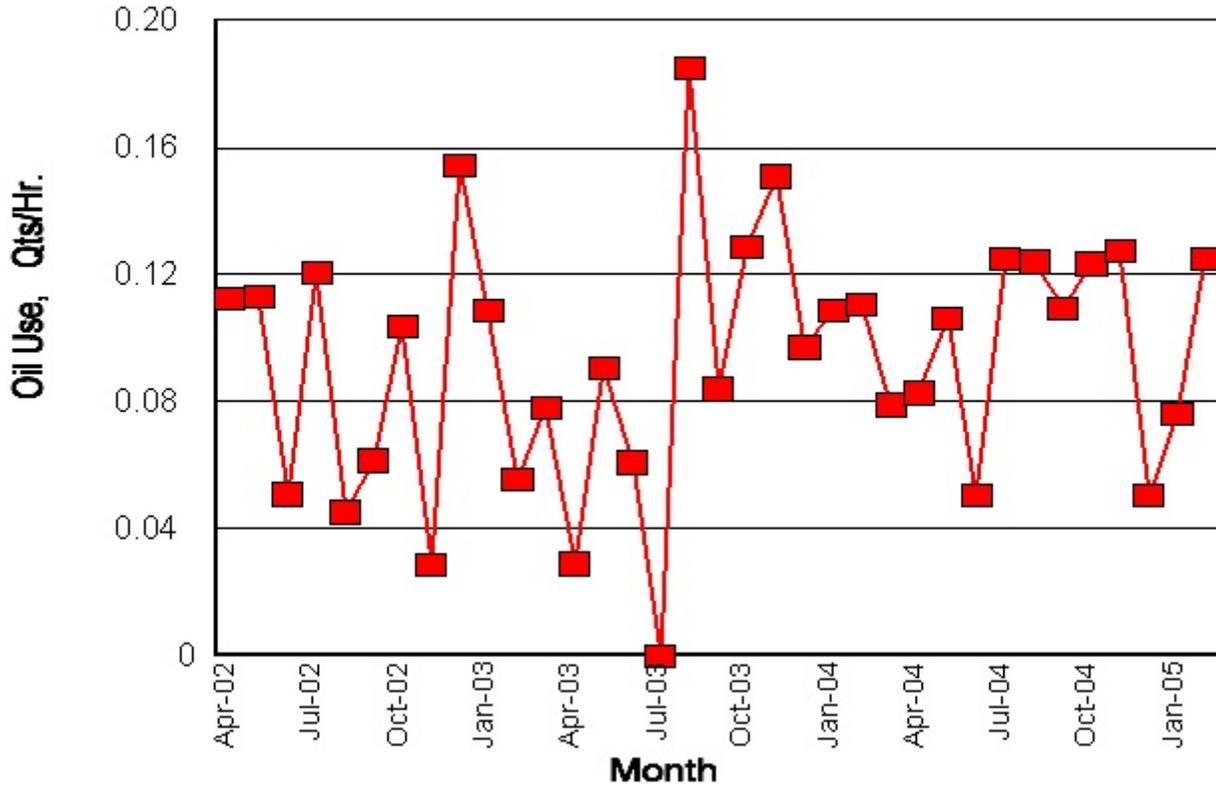
Oil Use History

Should Not Exceed 0.5 Qts/Hr.
